## **INTRODUCTION**

### **The Plan Itself**

## SECTION 1 - UNDERSTANDING THE HERITAGE

### 1.1 The Heritage of the Site

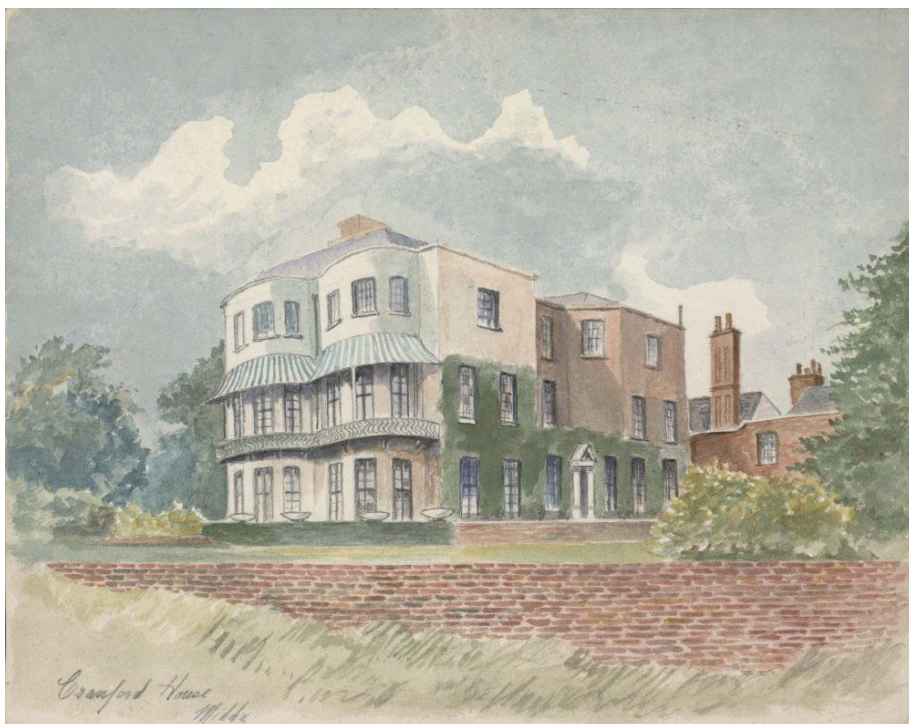
Cranford House from the South-East, undated, Gill collection, Orleans Gallery, Twickenham

Cranford House, a very substantial, three storey, early 18<sup>th</sup> century and later building of some 40 rooms, was not re-occupied by the Berkeley family after 1918 and was finally demolished in 1945. The house was razed to the ground and the area later fenced with a perimeter steel palisade fence. Scrub now covers the site. Trial archaeological excavations in 2018 and 2019 have demonstrated that the foundations of the front wall of the house and the stone passageway in the servants' wing have survived well at ground level, suggesting that more will be discovered. Other than this, only the cellars of the house remain.

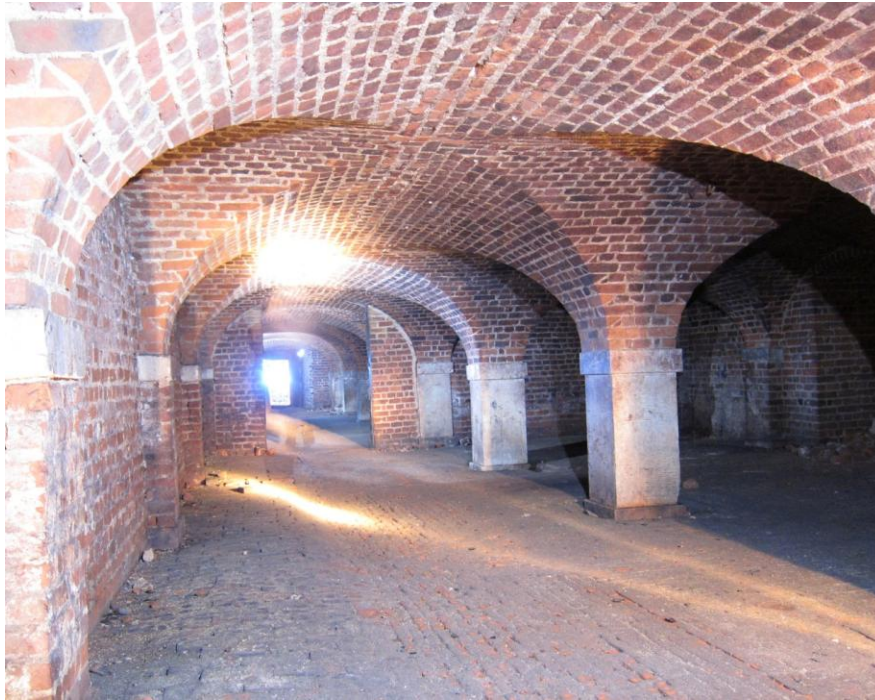
The Cellars looking north, by R. Barton 2015

The current entrance stair to the cellars, with metal trapdoor, was historically an external access, avoiding the need to go through the house. It may have been modified for use as an air raid shelter, although local memory suggests it was never used as such. There is a persistent rumour of an escape tunnel from the cellars to the ha-ha.

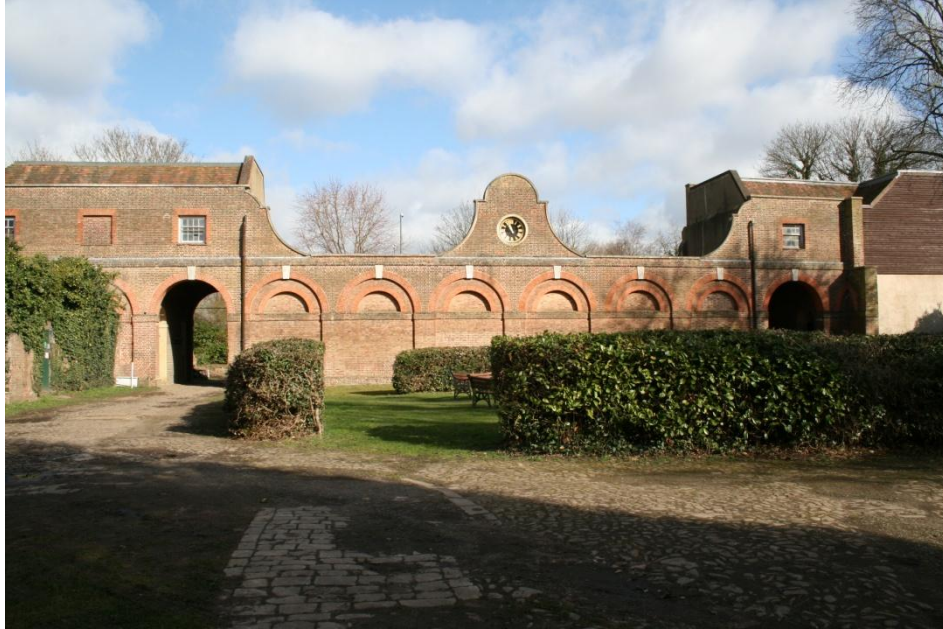
The Stables, by A. Lad 2015

The stables were built by the 3<sup>rd</sup> Earl in the 1720's. They comprise a rectangular building of brown brick with red dressings, of three elements. The central section has a facade with parapet, large semi-circular arched blind arcading and a central Dutch gable with inset clock. At the rear of this is a more recent, lean-to structure of no architectural merit, accessed via a compound at the rear.

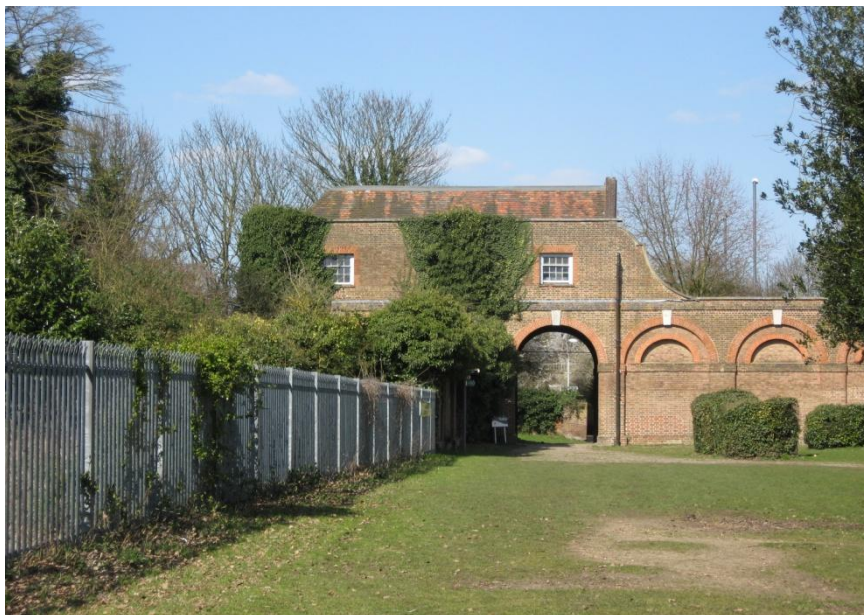
The western end of the stables and site of Cranford House (within the railings) by C. Baker 2014

On either side of this section is a tall arched entrance, the eastern arch still retaining its huge timber gates, the western one retaining only the supporting pins of its former gates. To either side of the arches are two-storey structures with stables at ground floor and rooms above, reached by external staircases.

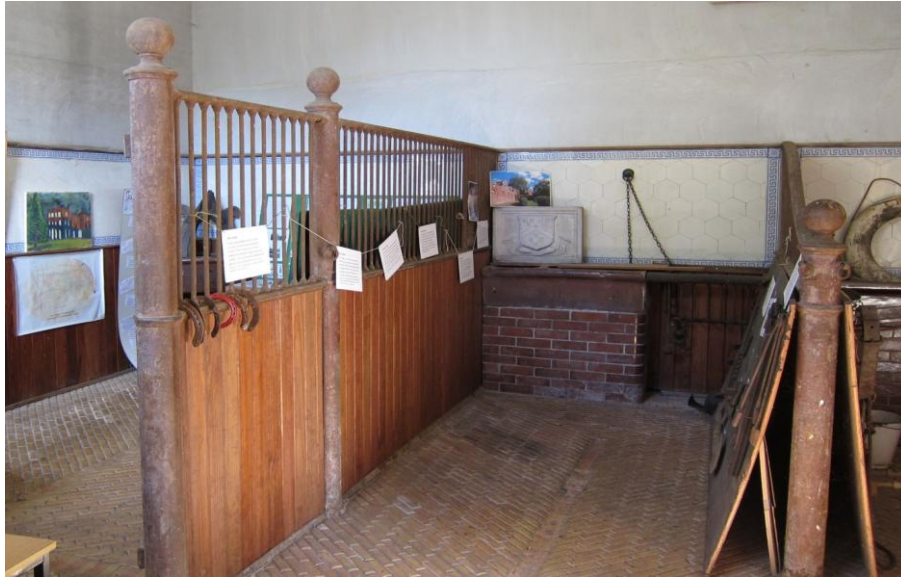
Stall in the western stable block, by C. Baker 2014

The western stable has a loose box and two stalls, with 18<sup>th</sup> century mangers, troughs, hay baskets, wall tiling, stall dividers, retaining rings and a herring bone brick floor with drainage gulleys. There is a ventilation shaft which passes through the ceiling and is opened and shut by a paddle on the landing above. The eastern stable has four stalls, again with 18<sup>th</sup> century fittings intact and the termination point for a ventilation shaft. The Stables now house memorabilia and old photographs.

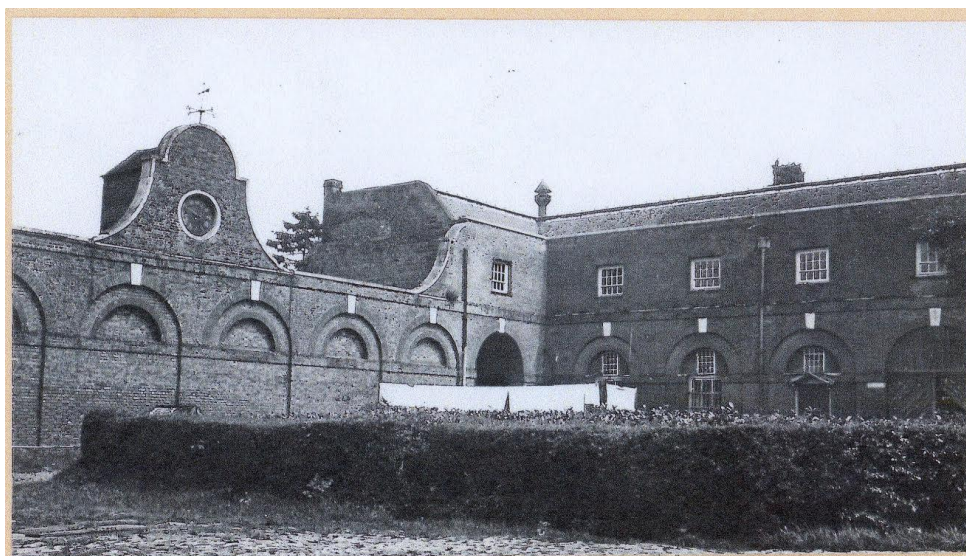
MB166

The Stables, Cranford Park Middlesex, showing the now demolished East Wing.  
Copyright English Heritage c. 1936

There was once a two-storey wing at right angles at the eastern end of the stables, demolished in 1945. This appears to have been used for stabling but also contained an open carriage shed. Old photographs and drawings show that this had the same tall semi-circular arcading as the front facade.

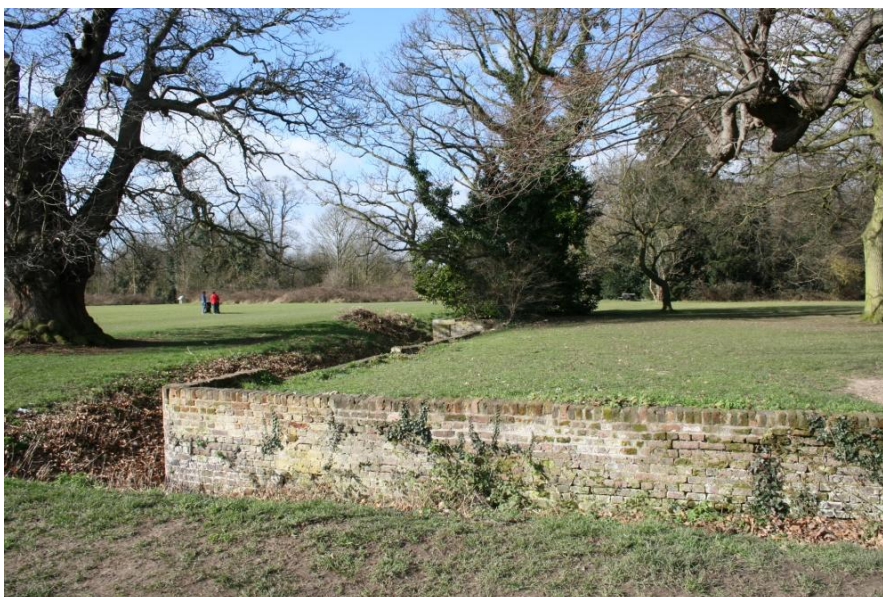
The eastern corner of the ha-ha, by A. Lad 2015

The ha-ha comprises a brick retaining wall with a deep ditch on the outer side to prevent animals straying into the gardens, orchard and woods from the meadow.

A square ha-ha is shown on the 1720 map, completely enclosing the garden, from the driveway right round to the wall which formed the garden's northern boundary. However, at some later time, the southern arm was extended to defend the woodland and orchard, so forming a 575 metre long structure with a bridge half way down and a flight of steps. Later too, when the eastern part of the garden was used for greenhouses, a small part of the western arm was infilled to allow access through to the orchard.

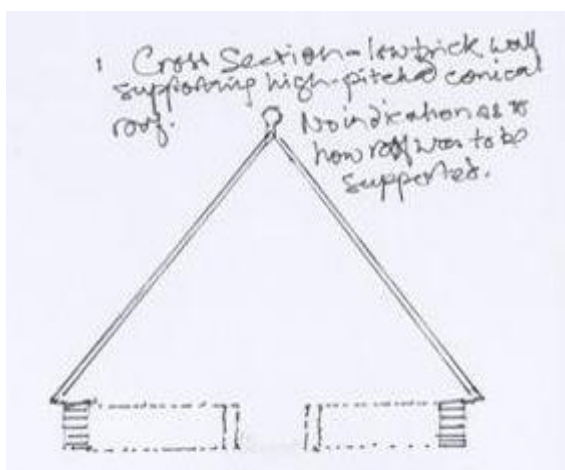
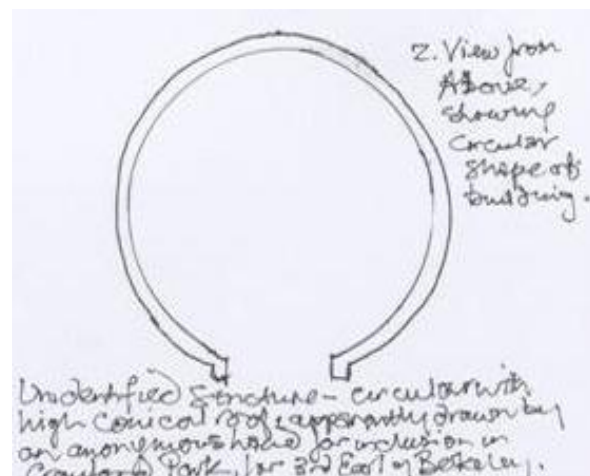
Drawings in the margins of the Coke Papers, may depict the ice house. If this is so, the structure would have had a circular brick chamber, with an opening and a conical roof rising from a low brick wall.

(COKE PAPERS (SERIES III) Vol. XXX: Architectural Papers of Thomas Coke.

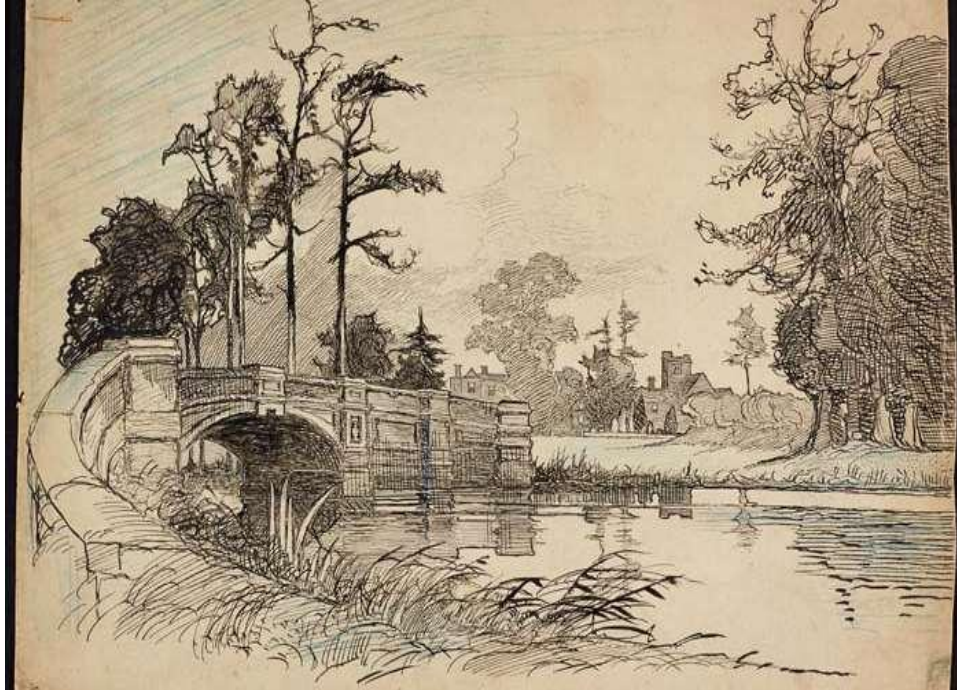
Historic England Archive: CGH01 0075, 1892-1933 CG Harper Collection

The driveway bridge was designed in 1805 by the Architect Charles Beazley, as part of the 5<sup>th</sup> Earl's modernisations. The Berkeley archive contains some original drawings. It is a single track, hump backed bridge, constructed of red brickwork, covered more recently in a hard cement based render. It consists of a segmented arch with a plain keystone. The piers on either side have semi-circular rusticated

plinths that were originally designed to carry decorative urns. The panelled walls supporting the sloped approaches to the bridge curve out in quadrants of an oval, to curve around the former moon ponds. There is a 6 tonne axle weight limit to protect the bridge from structural damage by heavy vehicles.

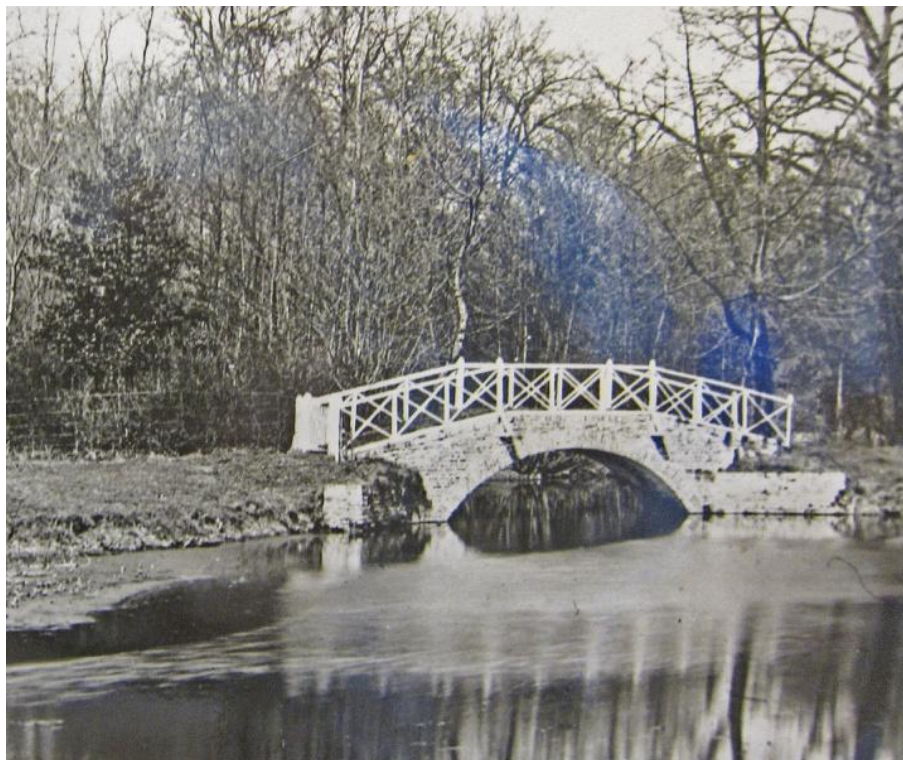
'Chinese Bridge' over the link between the River Crane and the ornamental lake. In 1961, the construction of the M4 Motorway began, just beyond the fence line in the photograph

The northern canal was fed by the River Crane, at an angle, part way down its length, the junction being later adorned with an ornate, curving 'Chinese' foot bridge'. This bridge was probably added by the 5<sup>th</sup> Earl, seeking a more naturalistic landscape, and fashionably drawing inspiration from Chinese gardens. He may also have added what may have been a 'temple' summerhouse at the head of the canal, a structure apparent on the 1820 plan of Cranford Parish.
